# Manhole Inspection Summary

Manhole # S25KK\_021MH

Insp Date: **8/27/07 9:43 AM**

**Location** Address: **2252 MADISON AVE**

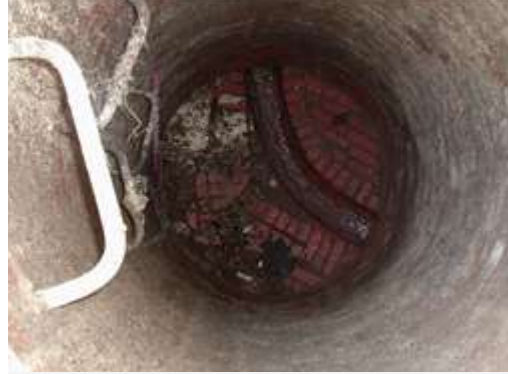
Top View

Corroded steps. Evidence of surcharge - Bench debris.

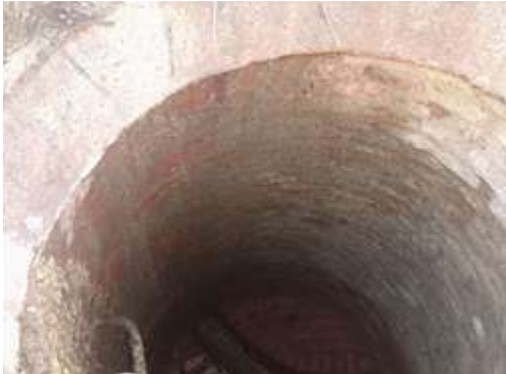
Defect

Frame leaks. Frame offset. Adjustment deterioration and infiltration. Corbel and Barrel infiltration - other side.

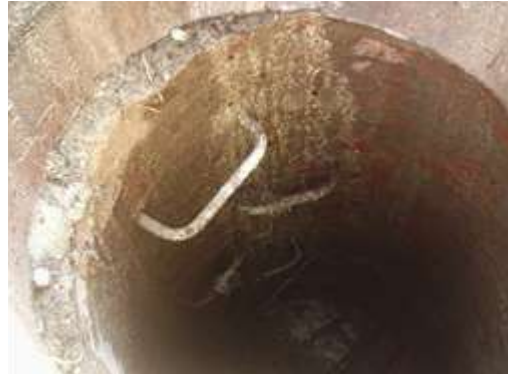
Defect

Frame leaks. Frame offset. Adjustment deterioration and infiltration. Corbel and Barrel infiltration.

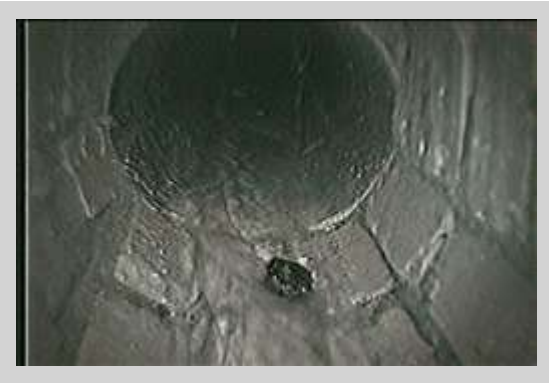
### 8 in. Circular Gravity Sewer Pipe Out @ 12 O'Clock

Infiltration: **None** Pipe Seal Cond: **Unknown**

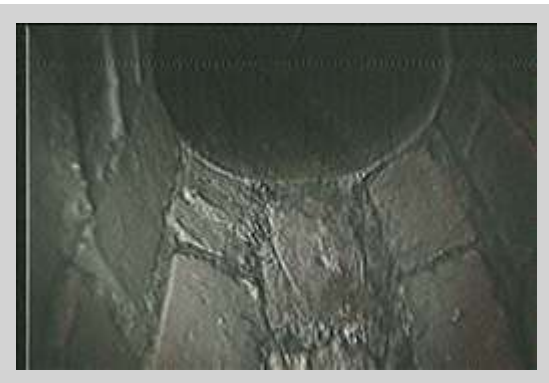
### 8 in. Circular Gravity Sewer Pipe In @ 4 O'Clock

Infiltration: **None** Pipe Seal Cond: **Unknown**
